**Structural Health Monitoring of concrete structures by  
integrating Infrared Thermography with compatible Non-  
Destructive Tests to quantify and characterize defects**

A Thesis submitted in partial fulfilment for the Degree of

**DOCTOR OF PHILOSOPHY**

in Civil Engineering  
Faculty of Engineering  
GOA UNIVERSITY

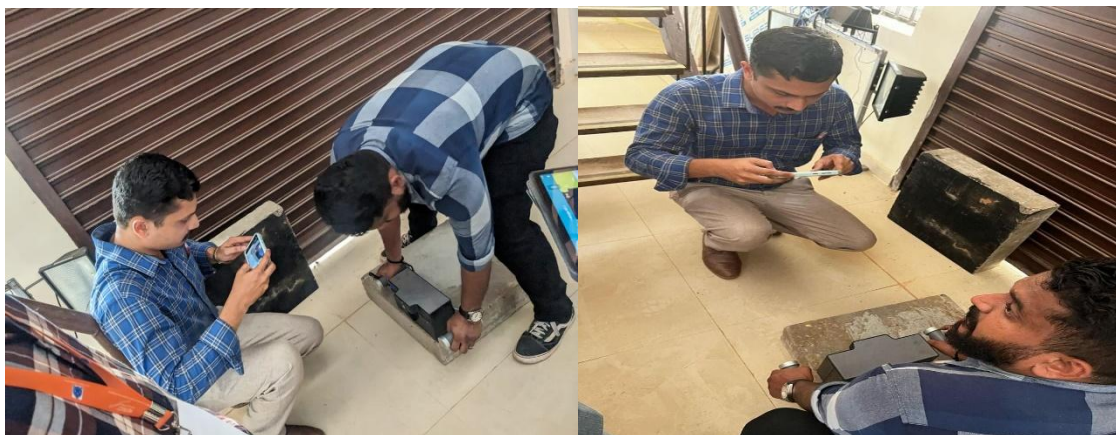
**Figure 90 UPE B-scan of concrete slab**
